METALS HANDBOOK

VOL. 9
FRACTOGRAPHY AND ATLAS OF FRACTOGRAPHY

8th EDITION

Fractography and Atlas of Fractographs

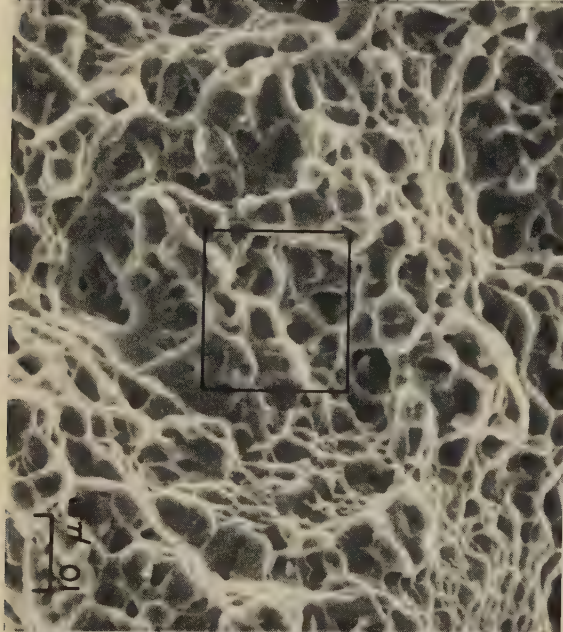
4179 A view of the fibrous central zone of the fracture surface in 4178, showing the equiaxed dimples expected in this region. The dimples are relatively uniform in size, with none being extremely large. A few inclusions are evident. See 4180 (area in rectangle, enlarged).

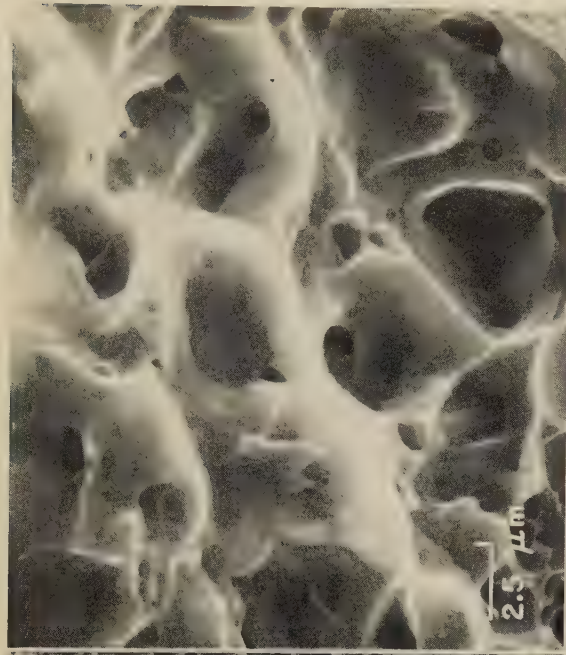
4180 Area outlined by the rectangle in fractograph 4179, as seen at four times the magnification there. Note the numerous small dimples that are situated within the larger dimples. This ductile fracture exhibits no sign of secondary cracking.

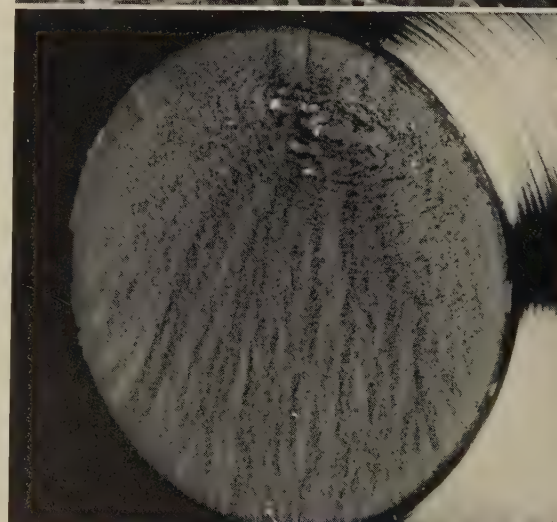
4181 Tensile-overload fracture surface of a notched specimen of titanium alloy Ti-6Al-4V heat treated to same mechanical properties as specimen in 4178, and with notched tensile strength of 1696 MPa (246 ksi). Crack nucleus is below center, at right. See 4182.

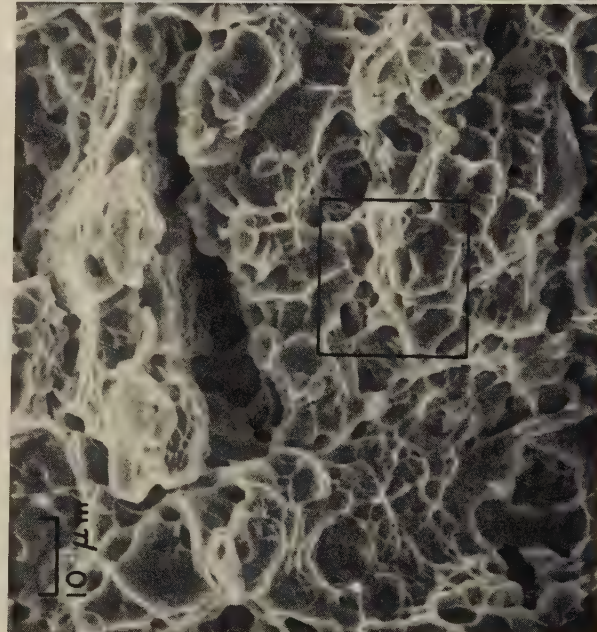
4182 Center of fracture surface in 4181. In contrast to the fracture surface of the unnotched specimen in 4179, dimples of various sizes are displayed here, and some secondary cracking is detectable. Also see 4183.

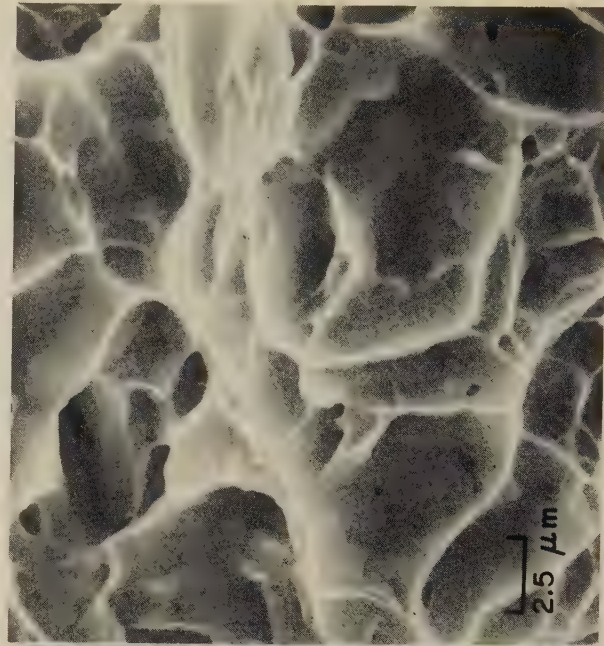
4183 A view at higher magnification of the area outlined by the rectangle in fractograph 4182. Note the small dimples that are present both at the edges of and within the larger dimples.

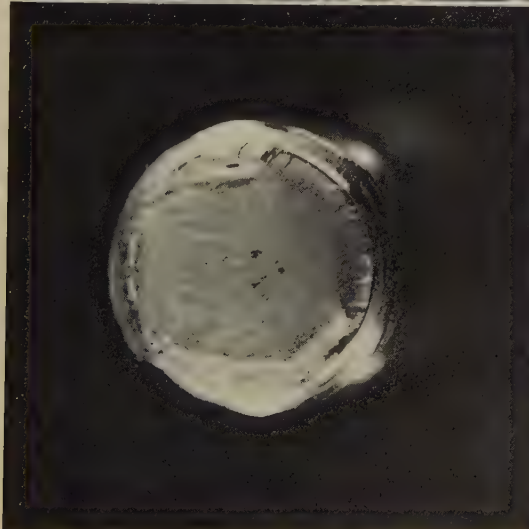
6×
4184 Fracture surface of a specimen of titanium alloy Ti-6Al-4V (same mechanical properties as in 4178, on facing page) broken in low-cycle fatigue (26,000 cycles) in tension-tension ($R = 0.1$) at maximum loading of 689 MPa (100 ksi). Several crack origins are visible at bottom. See also fractograph 4185, at right.

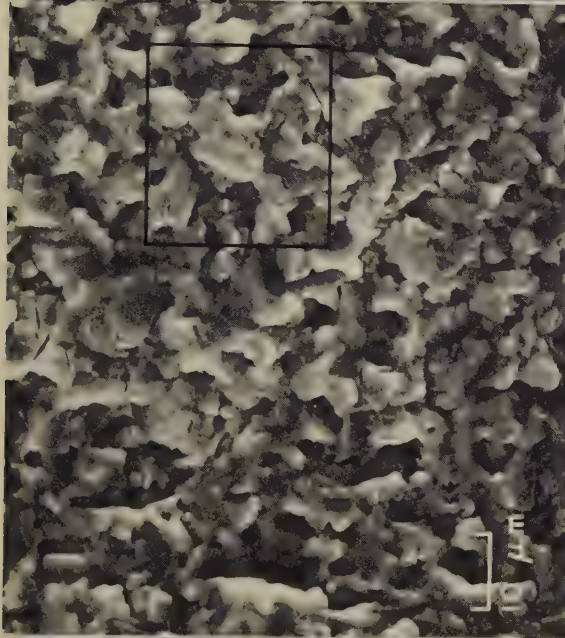
SEM fractograph
1000×
4185 A view of the fracture surface in 4184, showing an area close to the edge of the crack origins. Many small voids, which bear little resemblance to conventional dimples, are visible among the small facets. Area in rectangle is shown enlarged in 4186.

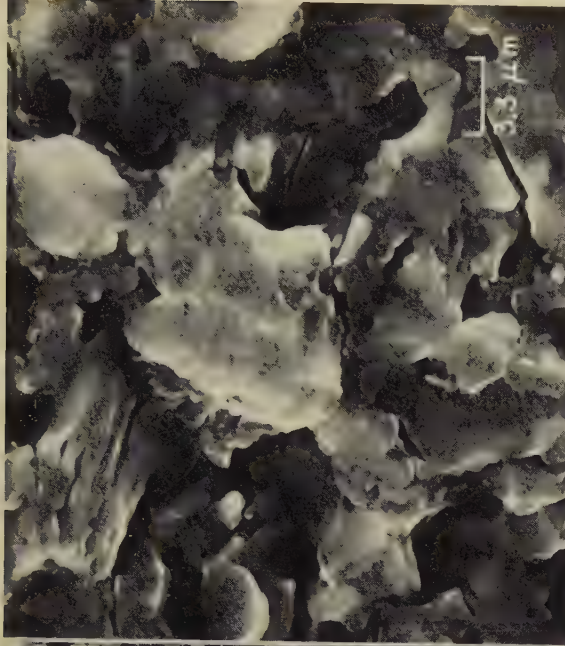
SEM fractograph
3000×
4186 Area outlined by the rectangle in 4185, as seen at triple the magnification there. Note the several small secondary transgranular cracks. The features at upper left are not considered fatigue striations, being too widely spaced (compare with TEM fractograph 4754).

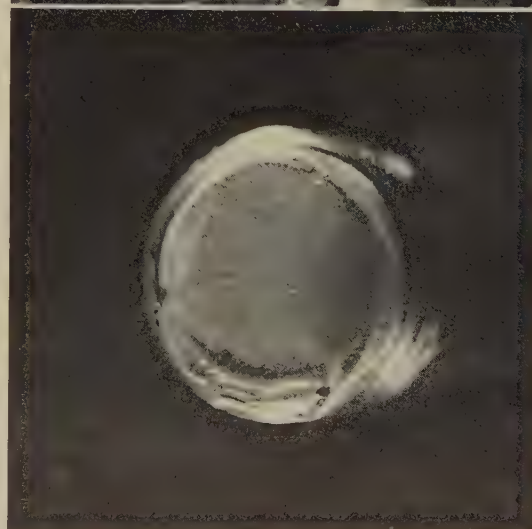
6×
4187 High-cycle fatigue fracture in a specimen of titanium alloy Ti-6Al-4V (same mechanical properties as in 4178, on facing page) that was tested in tension-tension ($R = 0.1$) at maximum loading of 345 MPa (50 ksi), breaking in 937,000 cycles. The curved fatigue beach mark can be seen near bottom. See 4188 and 4189.

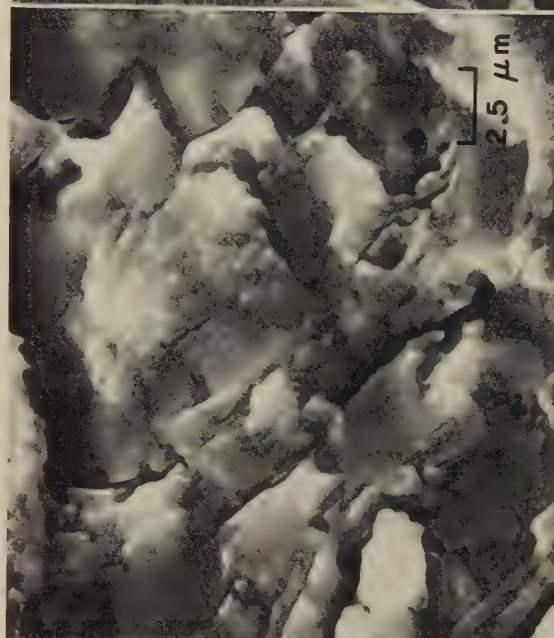
SEM fractograph
4000×
4188 View of fracture surface in 4187 showing an area at the curved beach mark. As in 4186, the parallel fissures are not believed to be striations, because their spacing is at least three times that of the features visible by transmission electron microscopy at the same site (see also TEM fractograph 4759).

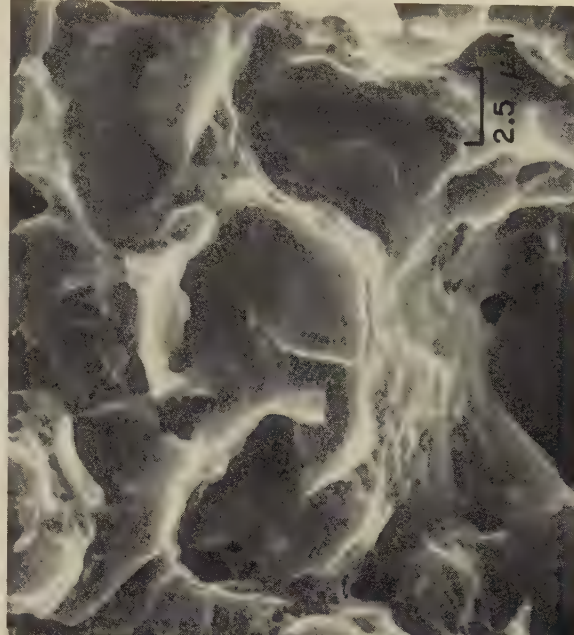
SEM fractograph
4000×
4189 Another view of the fracture surface in fractograph 4187, this one showing an area in the rapid-fracture region beyond the fatigue beach mark. Fine tear dimples are distinctly evident on the walls of the larger dimples. No fissures or secondary cracks are visible here.

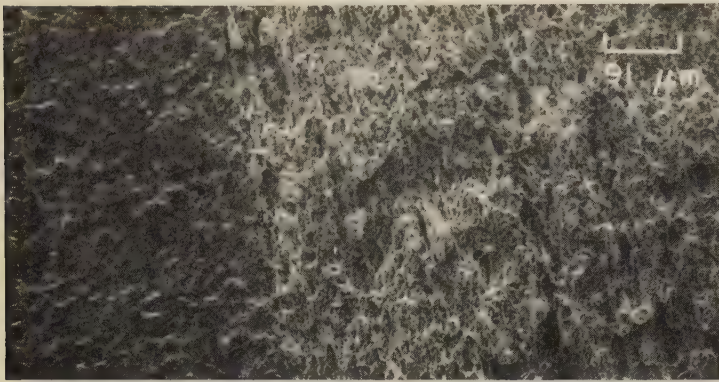
SEM fractograph

4190 Fracture surface of a specimen of titanium alloy Ti-6Al-4V mill annealed sheet that was fracture-toughness tested in air. At left (dark) is fatigue-precrack region; at right is region of tensile-overload fracture, which is dimpled and has aligned elongated cavities suggesting localized slip. See 4191.

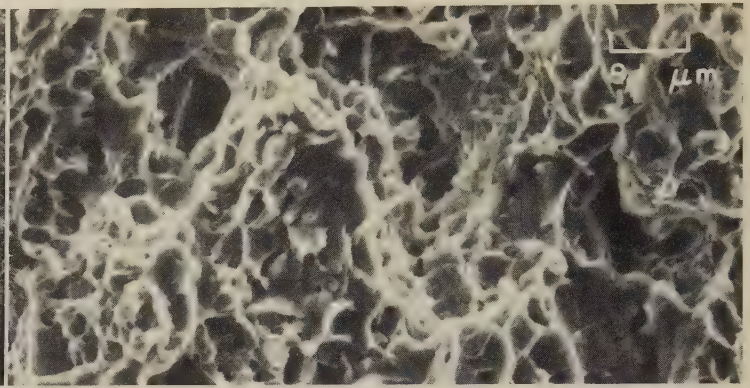
SEM fractograph

4191 A portion of the tensile-overload-fracture region of the fracture surface in 4190, as seen at ten times the magnification there. This displays a rather uniform size of equiaxed dimples, shows essentially no inclusions, and contains no indication of secondary cracking; in summary: a thoroughly ductile fracture.

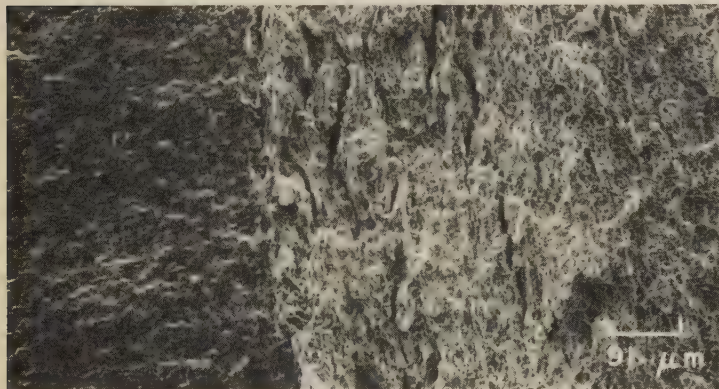
SEM fractograph

4192 Fracture surface of a specimen of the same material and condition as in 4190 (mill annealed Ti-6Al-4V sheet) but fracture-toughness tested in hydrogen at 1 atm. The fatigue-precrack region (dark area at left), produced in air, is identical with that in 4190, but note the deep cracks among the dimples in the tensile-overload region at right. See also fractograph 4193.

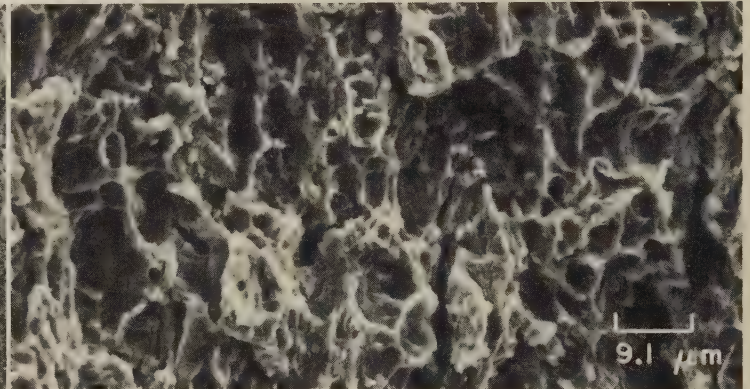
SEM fractograph

4193 A view of the region of tensile-overload fracture in 4192, at ten times the magnification there. In spite of the effects of hydrogen, this region is quite similar in appearance to the tensile-overload region of the air-tested specimen in 4191. Observe, however, that here there are many fine, parallel secondary cracks scattered throughout the dimpled surface.

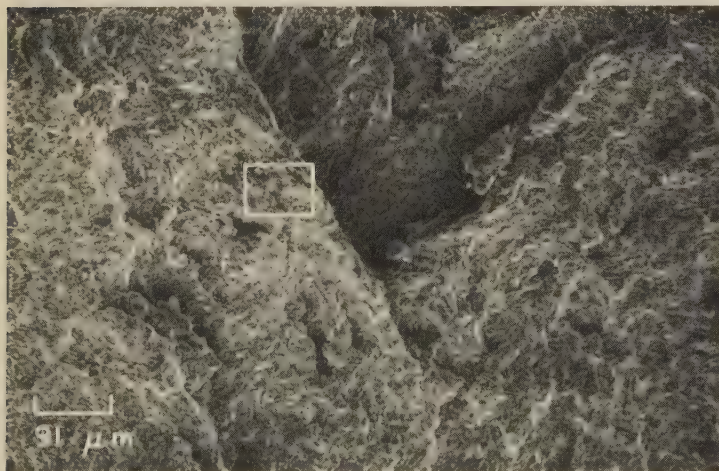
SEM fractograph

4194 Same as 4192, except that before being fracture-toughness tested in hydrogen, this specimen was heat treated at 704 C (1300 F) for 2 hr and air cooled. In contrast to the fracture surface shown in 4192, no dimples are evident here. The surface exhibits giant steps. See also fractograph 4195, at right.

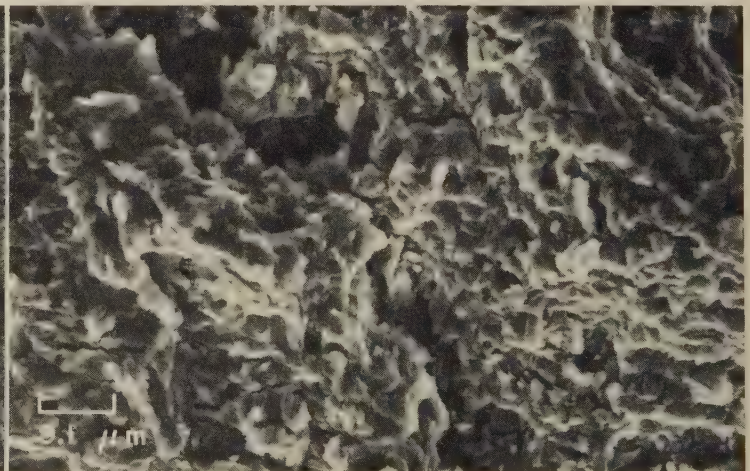
SEM fractograph

4195 Area outlined by the rectangle in fractograph 4194, as seen at ten times the magnification there. The rim of the central step in 4194 is at top right, and secondary fissures extend diagonally across the view. This surface contains no large cleavage facets, and has been characterized as "feathery".

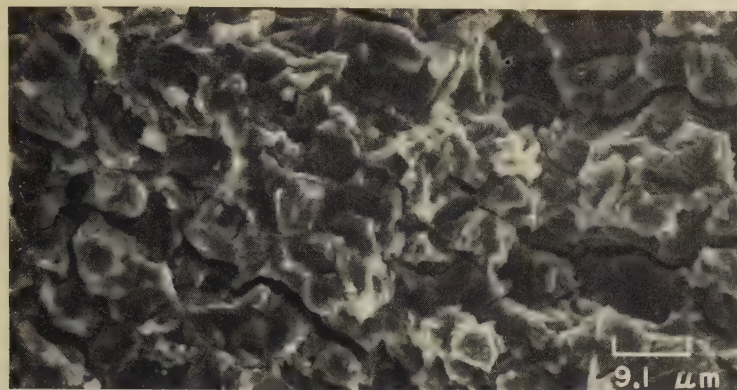
SEM fractograph

4196 Fracture surface of a fracture-toughness specimen of titanium alloy Ti-6Al-4V that was heat treated for 40 min at 954 C (1750 F), stabilized* and then tested at 25 C (77 F) in hydrogen. The deep secondary cracks are interpreted as following the boundaries between the grains of primary alpha and the beta matrix. See also fractograph 4197, at right.

*Stabilizing consisted of furnace cooling to 704 C (1300 F) from the heat treating temperature, holding 1 hr, furnace cooling to 593 C (1100 F), holding 1 hr, and air cooling. This treatment was used to secure a large grain size to increase the susceptibility of the alloy to slow-strain-rate embrittlement in hydrogen.

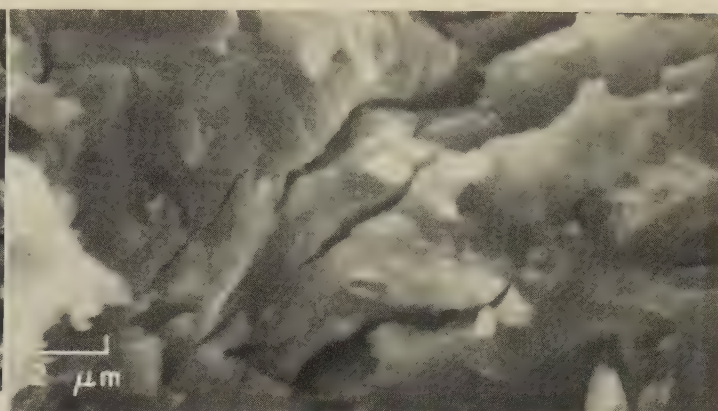
SEM fractograph

4197 A view of the fracture surface in 4196 as seen at higher magnification, which shows in greater detail the fine secondary cracks; these are transgranular in contrast to the network of major secondary cracks. The fracture is brittle, but the facets are small and irregular and have no detectable river patterns.

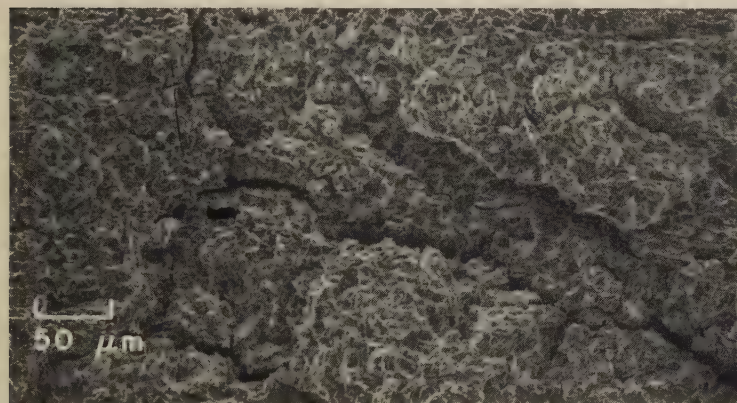
SEM fractograph

4198 Fracture surface of a fracture-toughness specimen same as in 4196, except this specimen received a 24-hr soak at 954 C (1750 F) before undergoing the stabilizing treatment.* A gross network of secondary intergranular cracks is evident, providing steps that separate different levels of the main crack advance. See also fractograph 4199, at right.

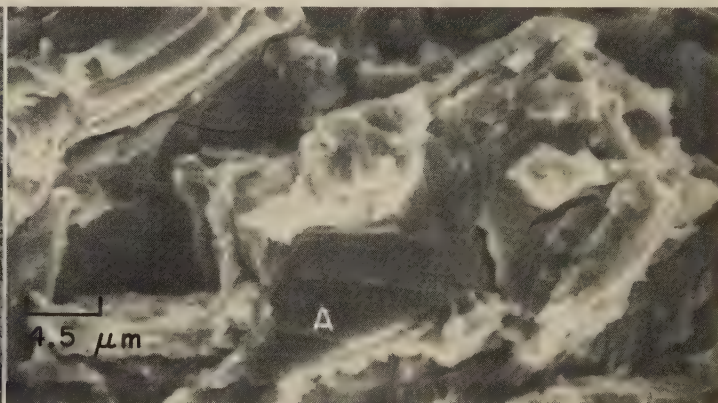
SEM fractograph

4199 A view of the fracture surface in 4198, at 11 times the magnification there. Note the intricate rupture patterns. Some of the main cracks are believed to follow the interfaces between the continuous beta-phase matrix and the dispersed acicular alpha phase. Observe the "terraced" area at A; similar areas are visible in fractographs 4205 to 4207, on the next two pages.

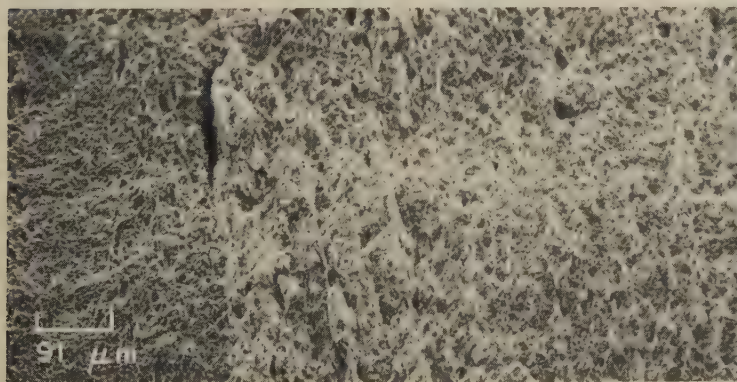
SEM fractograph

4200 Fracture surface of a fracture-toughness specimen of titanium alloy Ti-6Al-4V heat treated 40 min at 954 C (1750 F) and water quenched, aged at 510 C (950 F), and tested in hydrogen. The fatigue-precrack region is at left. The tensile-overload region, at right, closely resembles that of specimen in 4192.

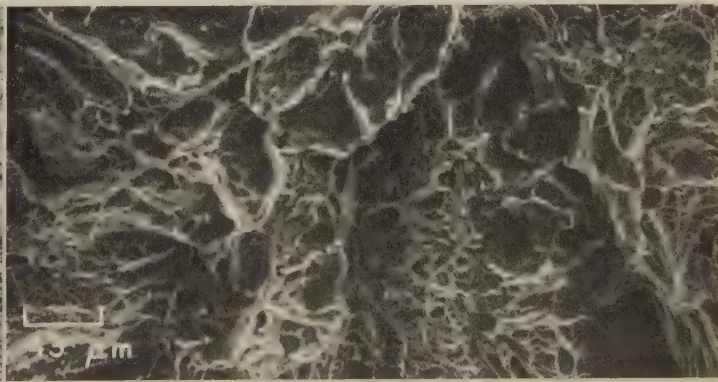
SEM fractograph

4201 Fracture surface of a fracture-toughness specimen of titanium alloy Ti-6Al-4V that was heat treated 40 min at 1038 C (1900 F), stabilized* and then tested in air at 25 C (77 F). Note the tremendous range in size of the dimples. See also fractographs 4202 through 4205, on the next page.

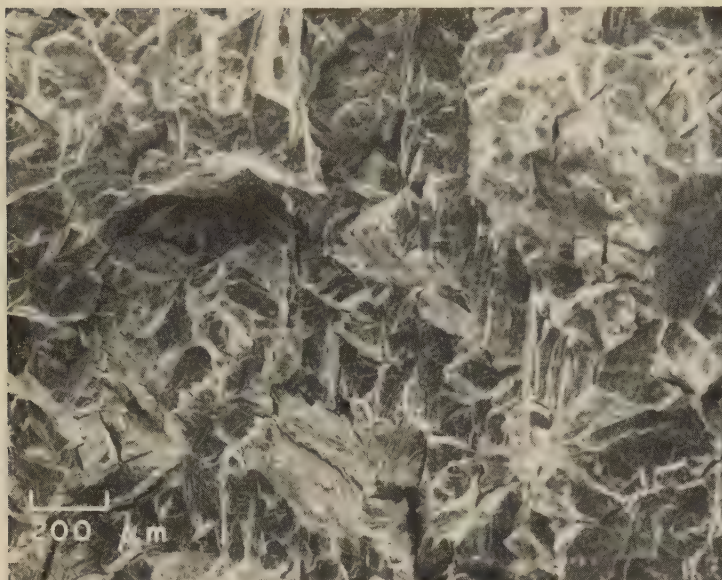
SEM fractograph 50×
4202 A Ti-6Al-4V fracture-toughness specimen identical to that in 4201 (preceding page) except broken in hydrogen at 25 C (77 F). This fracture surface appears to be very brittle, showing intergranular secondary cracks that follow exceedingly angular paths. Note the larger cleavage facets. See also 4203.

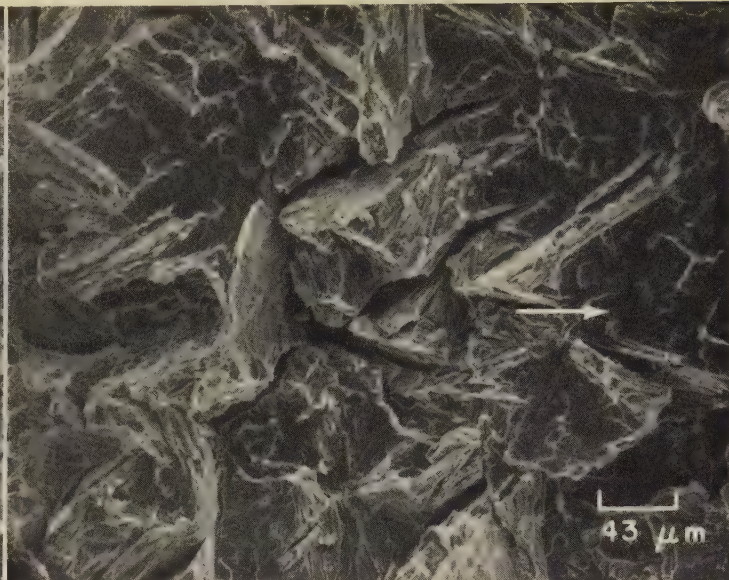
SEM fractograph 230×
4203 Higher-magnification view of the fracture surface in 4202, showing quasicleavage facets and detailed river patterns. Note particularly the unusual concentric pattern of steps at arrow, and compare it with the similar pattern of steps that is shown at higher magnification in 4205 (below).

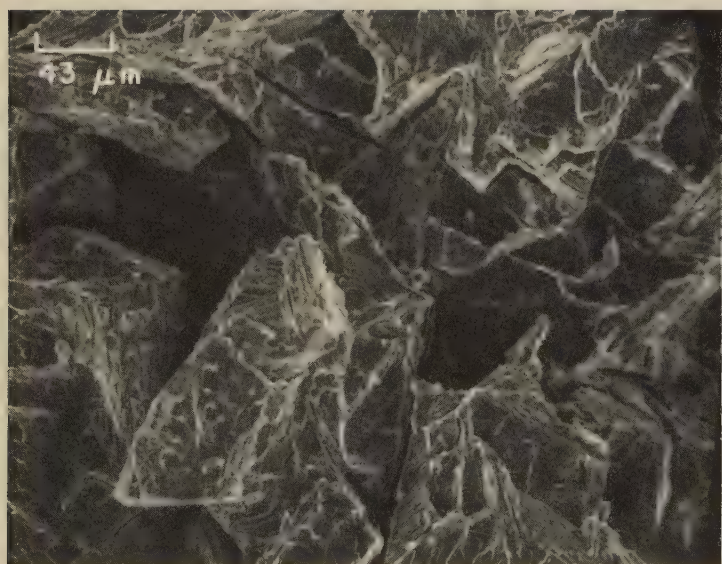
SEM fractograph 230×
4204 Higher-magnification view of the fracture surface in fractograph 4202, showing an area different from that in fractograph 4203. As in 4202, the very angular secondary cracking is noteworthy, and is believed to have been influenced by interfaces between beta phase and acicular alpha phase. Note the fine parallel steps on the angular facets at bottom right.

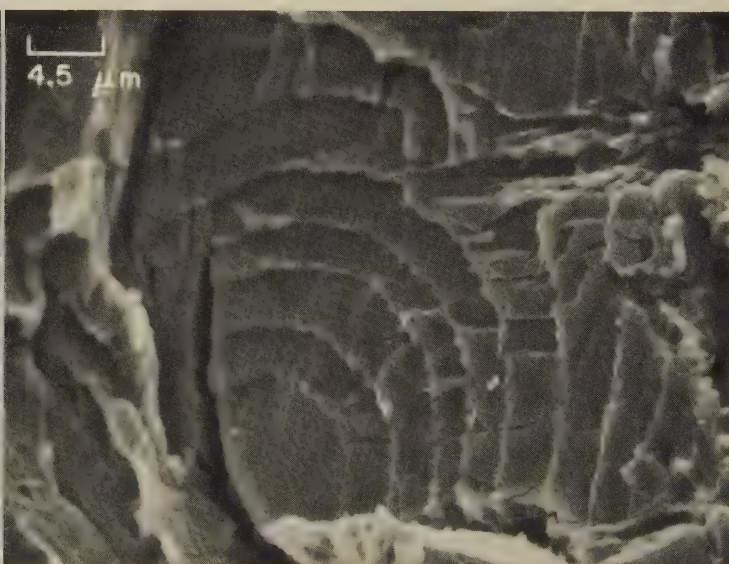
SEM fractograph 2200×
4205 Another view of the fracture surface in fractographs 4202 to 4204, at even higher magnification, showing a region containing a very unusual "terraced" facet that is similar to the area shown and discussed in 4203. It is possible that this relatively flat area was a prior beta grain. Observe also that the "terraces" have cleavage steps of their own.

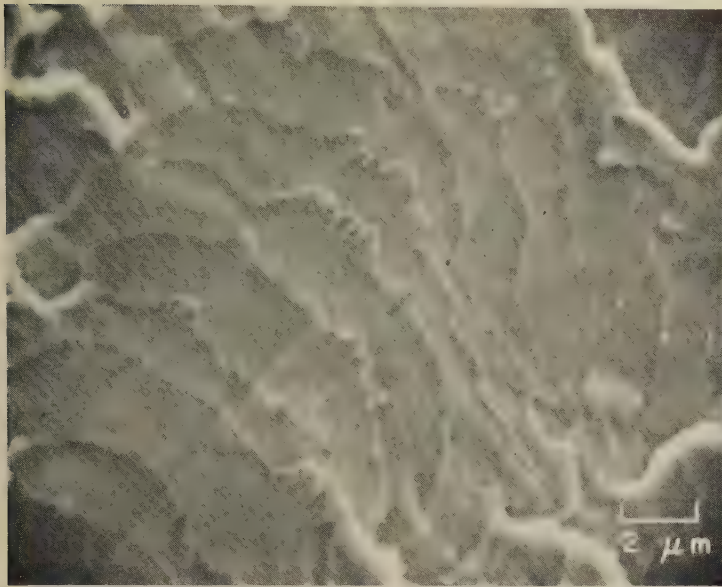
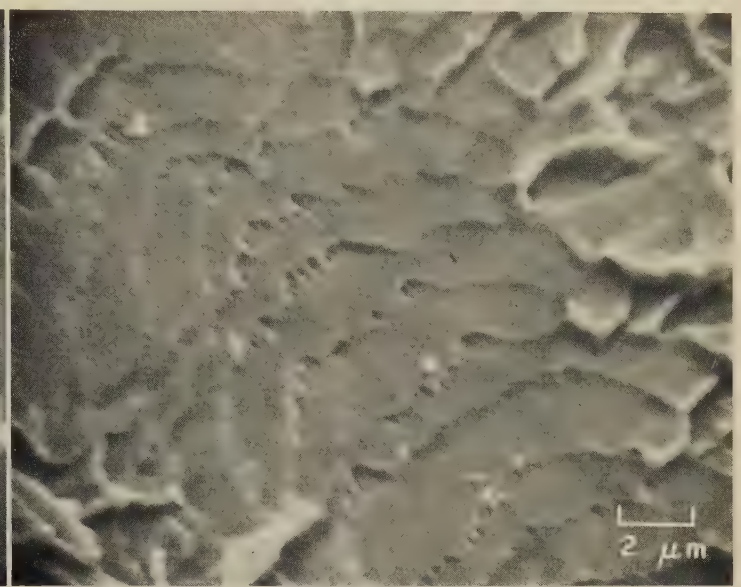
4206, 4207 SEM views of the mating surfaces in an area of the fracture shown in 4202 to 4205 that is very similar to the area shown in 4205. This particular type of "terraced" fracture surface was found to be characteristic of all Ti-6Al-4V specimens that have microstructures consisting of beta phase and acicular alpha phase and that have been fracture-toughness tested in a hydrogen atmosphere. Note that the edges of the steps appear to contain small dimples; this seems to be quite unusual in a fracture surface having many of the characteristics of cleavage.

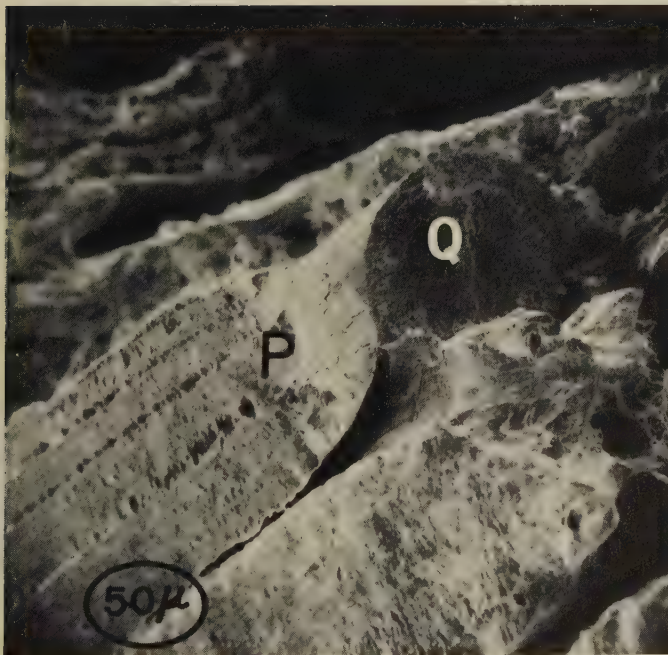
SEM fractograph

4208 Surface of a tension-overload fracture in a composite consisting of tungsten fibers in a silver matrix. The tungsten fiber marked P has undergone a ductile fracture with necking whereas fiber Q has suffered a sharp, flat, transverse cleavage fracture. See also 4209.

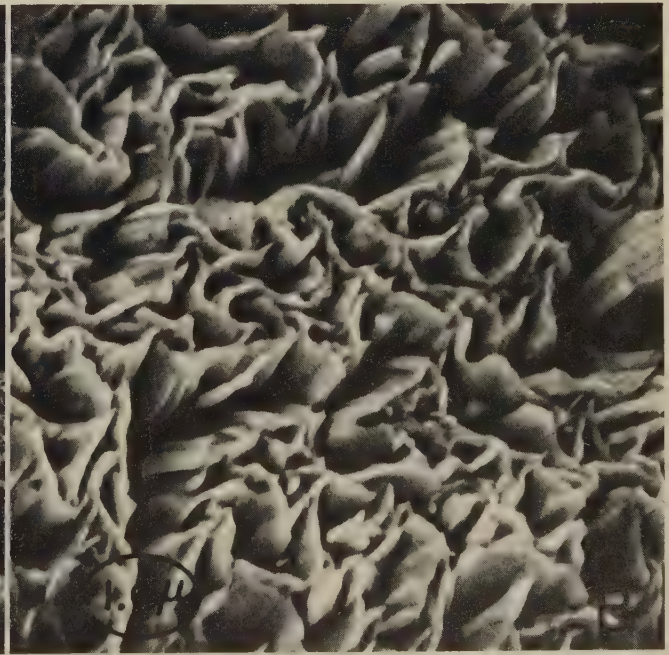
SEM fractograph

4209 Higher-magnification view of an area of tungsten fiber P in fractograph 4208 (left). Deformation during fracture has thinned the walls of the dimples to sharp edges, which shows the highly ductile nature of the fracture. Note the uniformity in height of the walls.

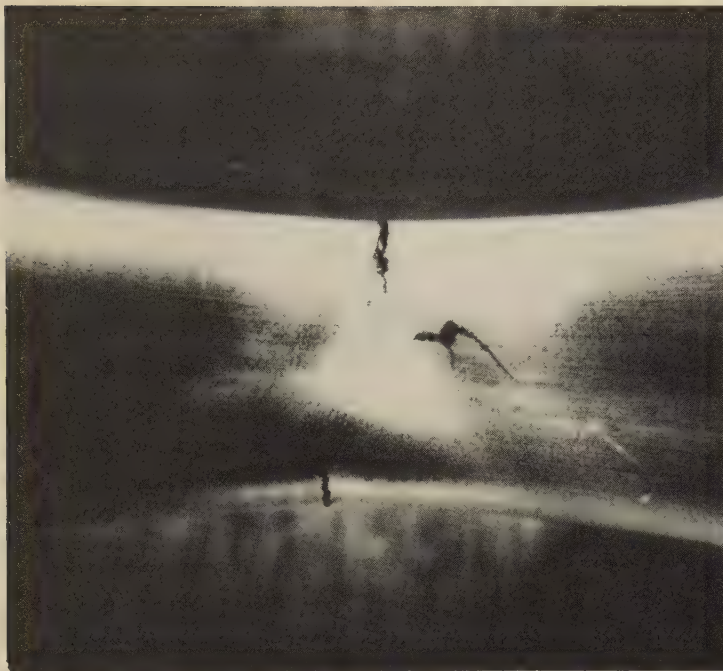
Photograph

4210 Surface of a partially fractured fatigue specimen of Zircaloy-2 (Zr-1.34% Sn-0.15% Fe-0.10% Cr-0.055% Ni) plate that had been initially annealed and cross rolled at 790 C (1454 F), rolled again at 430 C (806 F), and recrystallized at 625 C (1157 F) for 4 hr. Cracks are located at intersecting slip planes. Total plastic strain was 0.041. See also 4211 and 4212.

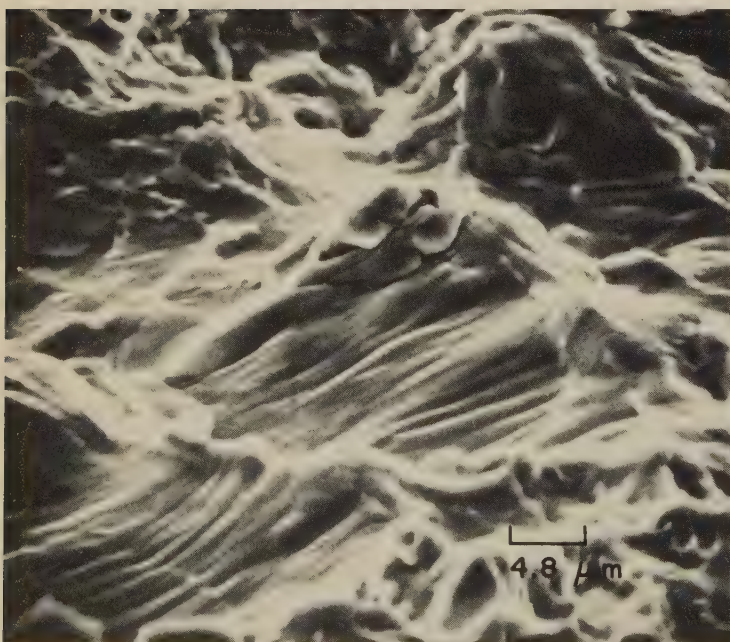
SEM fractograph

4211 Scanning electron microscope view of the surface of a fracture in a specimen similar to that shown in photograph 4210 (left), displaying a combination of dimples and fatigue striations. The applied loading was tension-compression; plastic strain was 0.0185, and failure occurred at 600 cycles.

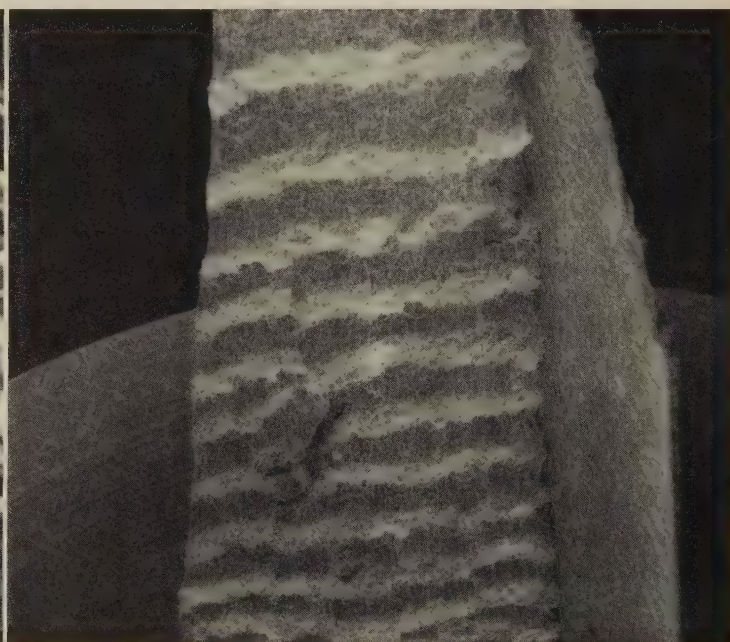
SEM fractograph

4212 Same fracture surface as in 4211, but a different area. The axis of the fatigue specimen was in the transverse direction of the plate. Thickness of the plate, 0.525 in. Final minimum specimen diameter was 0.250 in., obtained by longitudinal polishing.

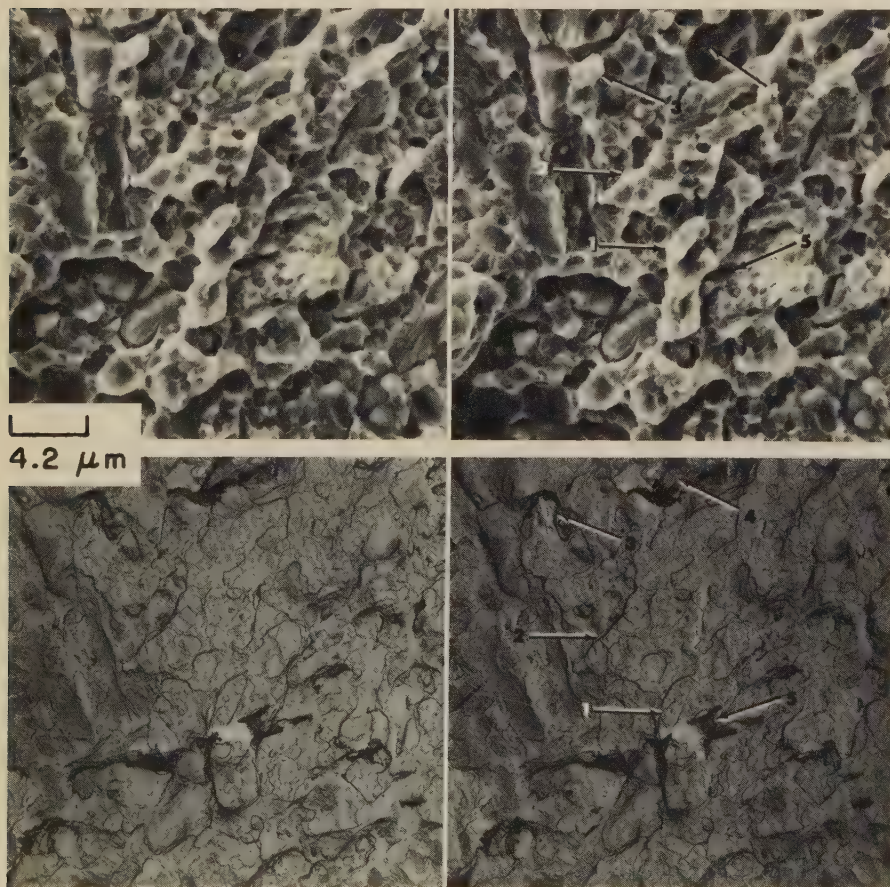
SEM (4214) and TEM (4215) stereofractographs 2400×

4214 Surface of a room-temperature impact fracture in plain carbon steel after heat treatment at 800 C (1472 F) for 5 min and oil quenching. The specimen was fractured untempered, at a hardness of Rockwell C 65. The fracture surface exhibits dimples resulting from microvoid coalescence, and small local areas of quasicleavage facets. Viewing these fractographs in 3-D assists greatly in recognition of the features that are common to both views. For instance, the roughly oval tip of a projection at arrow 1 in the SEM view can easily be identified in the TEM. A feature with a crudely triangular tip pointing to the left (arrow 2) is also readily recognized. The upper portion of this feature, however, appears much flatter in the TEM view than in the SEM, although local marks can be identified in each. Another site of conformance between the SEM and TEM stereofractographs is at arrow 3. Some details are lost at arrows 4 and 5 in the TEM pair, because of local tearing of the replica. See also fractographs 4216-4217 and 4218-4219, on the opposite page.

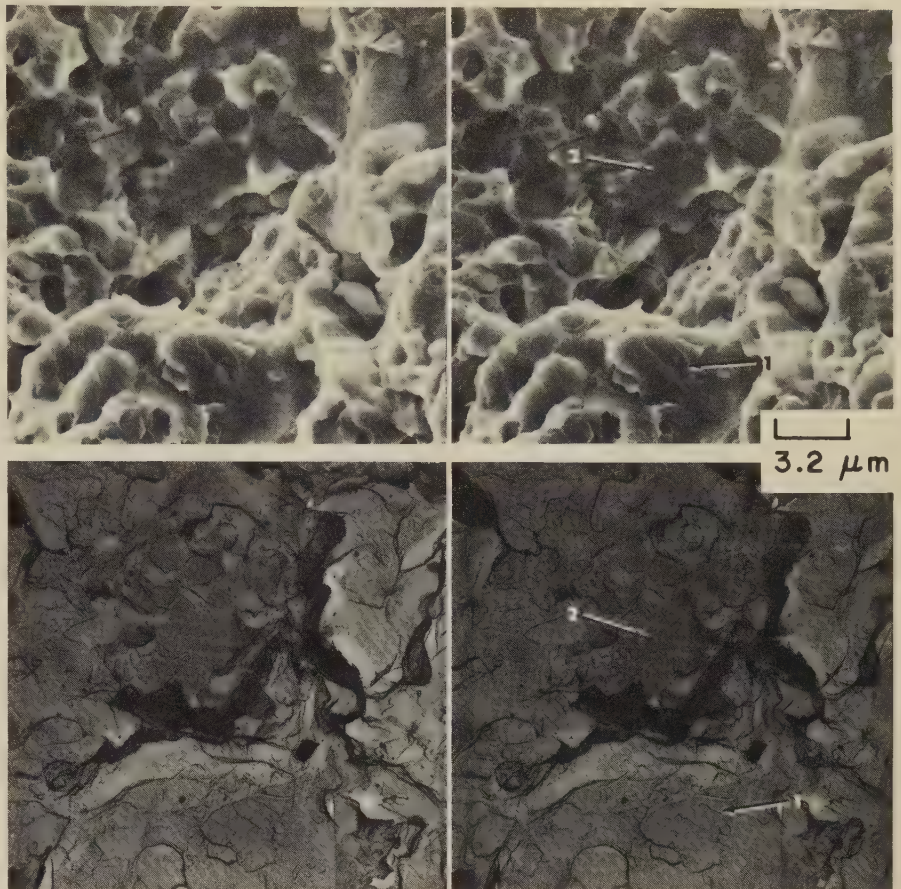
SEM (4216) and TEM (4217) stereofractographs 3100×

4216 A second set of SEM and TEM stereofractographs of the fracture surface in 4214
4217 and 4215 (room-temperature impact fracture in plain carbon steel), showing a different area and at higher magnification. Again, the fracture surface exhibits dimples and quasicleavage facets. Some of the latter are shown with much the same details in each stereo pair. At arrow 1, for example, both the SEM and the TEM stereofractographs display the same cleavage steps; the TEM view shows them more sharply but the SEM presents them in greater three-dimensional relief. Another example is at arrow 2; the facet is clearly recognizable, and has identical shape and orientation, in both reproductions, but the fine detail is more sharply registered in the TEM pair. The deep gulf between arrows 1 and 2 (viewing in stereo is essential to an appreciation of the contours of this gulf) is plainly shown in the SEM pair, but is obscured by tearing of the replica in this area in the TEM. Evidently, the depth of the gulf made stripping difficult. See also 4218-4219, below.

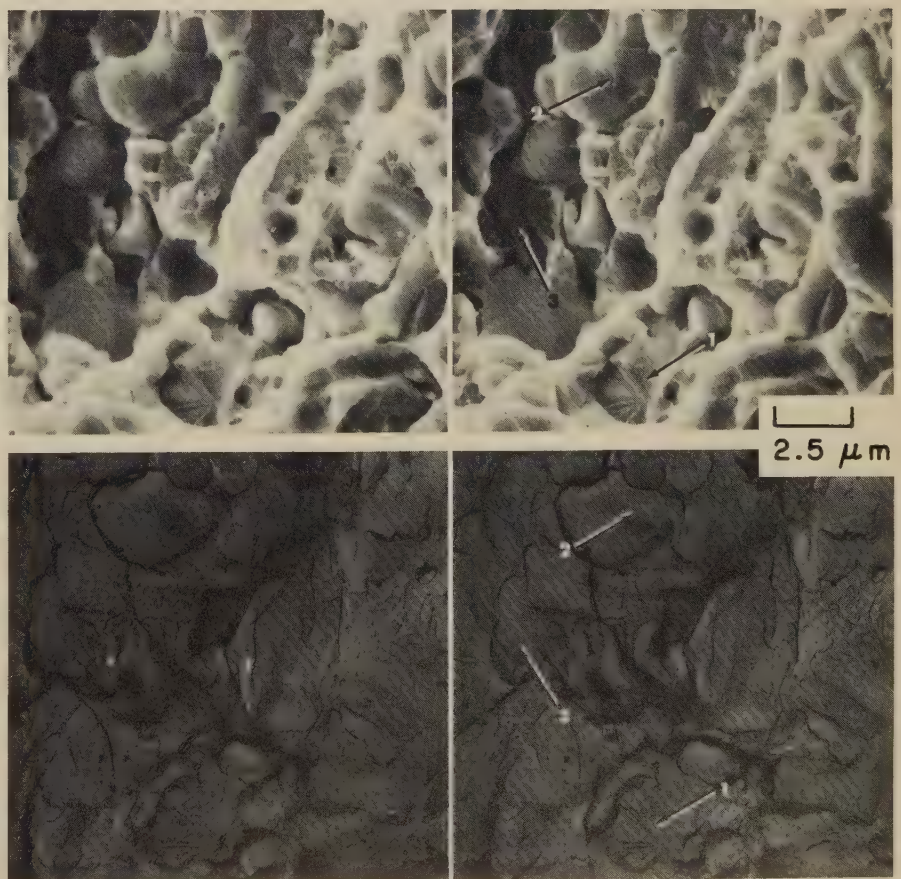
SEM (4218) and TEM (4219) stereofractographs 4000×

4218 A third area in the surface of the impact fracture in plain carbon steel in 4214-4215
4219 and 4216-4217, as presented by SEM and TEM stereofractographs at even greater magnification. The fracture characteristics resulting from microvoid coalescence and quasicleavage are unaltered. In the facet at arrow 1, both the SEM and the TEM views show the distinct, fan-shaped pattern of cleavage steps—again, as in 4216-4217, with the details more sharply outlined in the TEM. The small cavity just to the right in the SEM pair is, however, obscured by what is apparently a replica tear in the TEM. A similar contrast in details is available at arrow 2; both the SEM and the TEM views register the same fracture outlines, with the TEM view giving more fine detail and the SEM view presenting the major details in greater three-dimensional relief. Both pairs record the deep area (arrow 3) completely. One noteworthy item in the SEM pair is the veil-like feature just below arrow 3; this may be some remnant of the replica applied before the SEM fractograph was taken.

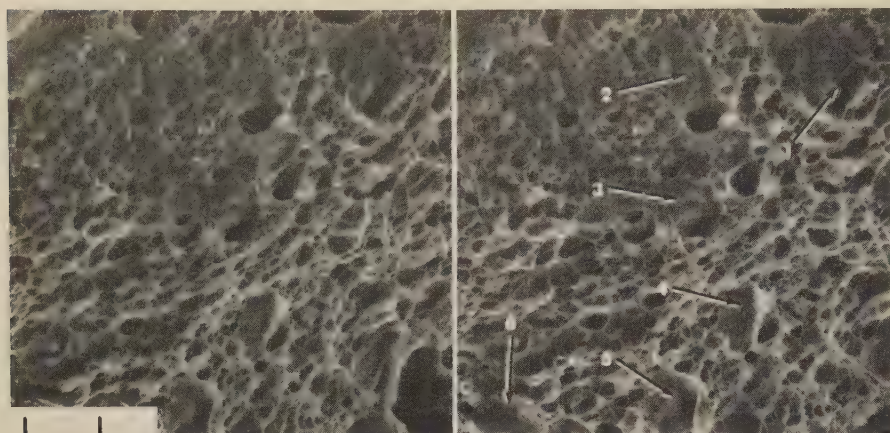
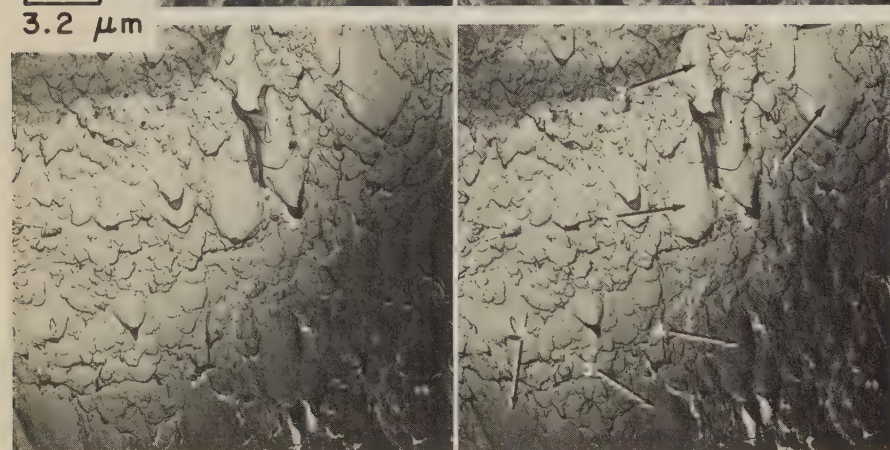
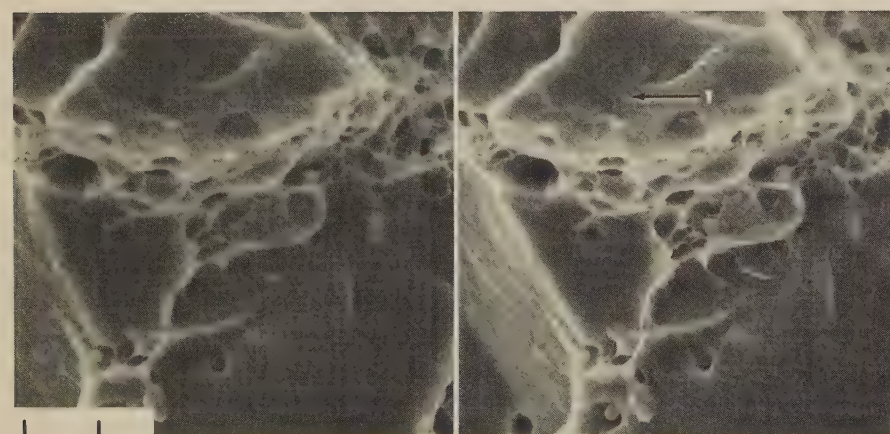
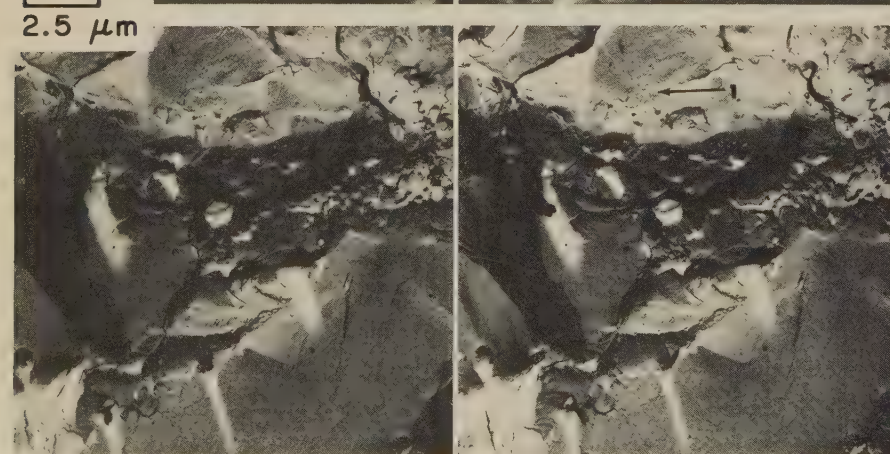
SEM (4220) and TEM (4221) stereofractographs 3100×

4220 Surface of a room-temperature impact

4221 fracture in low-alloy manganese steel
(0.60 to 0.70% C, 1.0 to 1.1% Mn) that was
oil quenched from 900 C (1652 F) before

being broken. The surface shows mainly shear dimples, some of which (at upper right in each stereo pair) are large enough to display areas of stretching. (It should be noted that a TEM replica of such large dimples may sag or collapse and, as in this comparison, introduce a very different appearance to the dimples from that displayed in an SEM view.) Specific dimples may be identified without question in each pair of views, and a number of these have been indicated by arrows 1 to 6. Observe, however, that the sense of depth, particularly in the larger dimples in the SEM pair, is quite lacking in the TEM. Nonetheless, the presence of an extremely large range of dimple sizes in this fracture surface is clearly established by the fractographs produced by both techniques. See also 4222-4223, below.

4222 Same room-temperature impact fracture

4223 in low-alloy manganese steel as in 4220-4221, but a different area of the fracture

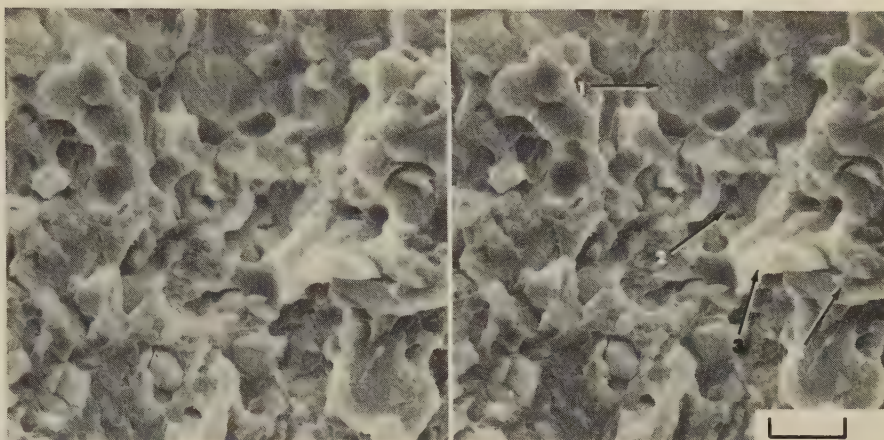
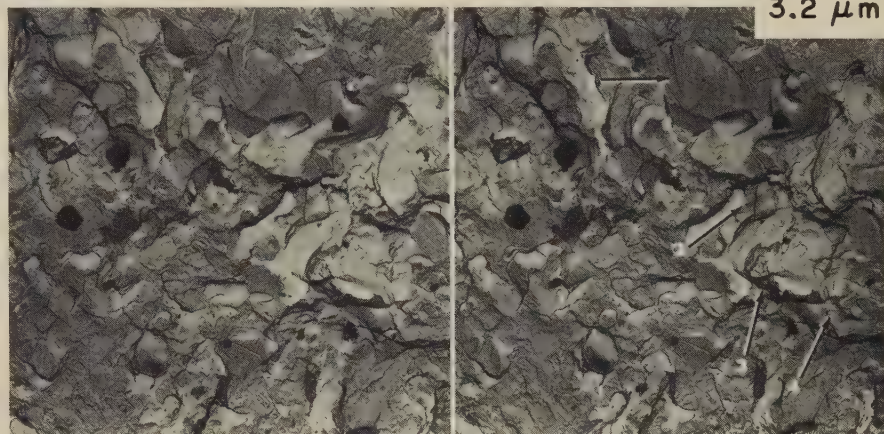
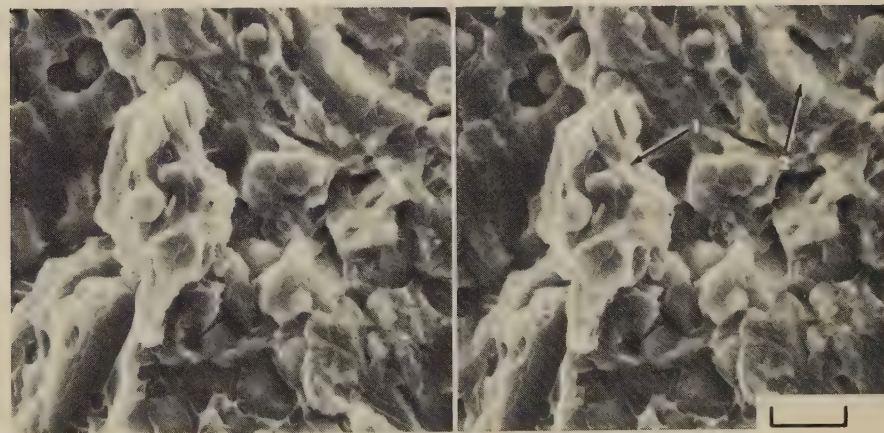
SEM (4224) and TEM (4225) stereofractographs 3100×

4224 Surface of a room-temperature impact fracture in a specimen of class 612 (T2) high speed tool steel having a nominal composition of 18% W, 4% Cr, 2% V and 1% C. The specimen had been heat treated for 5 min at 1200 C (2192 F) and oil quenched, and tempered for ½ hr at 500 C (932 F) and air cooled, yielding a hardness of Rockwell C 64. Surface shows quasicleavage facets and scattered dimples. In some of the features, the two fractographic techniques provide exact duplicates; in others, some details are missing from the TEM view. The region around the quasicleavage facet at arrow 1 is an example of quite good, detailed conformance between SEM and TEM, including the deep hole below (at arrow 2). At arrow 3, stereo viewing of the SEM pair reveals a very high prong that is not found in the TEM; this bears evidence that the replica tore very locally. Compare, however, the fine details that appear in both pairs at arrow 4, as well as at other points of duplication. See also 4226-4227, below.

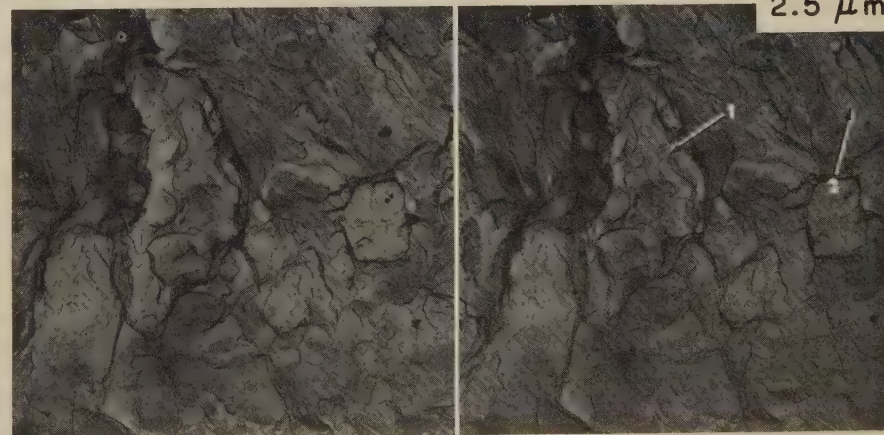
SEM (4226) and TEM (4227) stereofractographs 4000×

4226 Views of a different area, and at higher magnification, of the fracture surface in 4224-4225, above. This is a remarkably complex area, containing many small and varied quasicleavage facets and exhibiting a number of spheroidal inclusions. The most prominent feature is the high peak at arrow 1, which is reproduced in very faithful and identical detail in both stereo pairs. Note that the two inclusions between the twin tips of the peak are shown in both pairs, but that similar inclusions slightly nearer the top of the SEM pair are missing in the TEM because of damage to the replica. The top center area of the SEM view appears to record a greater number of surface complexities than does the same area in the TEM view; at arrow 2, however, the TEM view displays very fine fracture marks that cannot be found in the same location in the SEM view.
